7A Flight Readiness Review (FRR)

International Space Station Program

International Space Station Program June 28, 2001

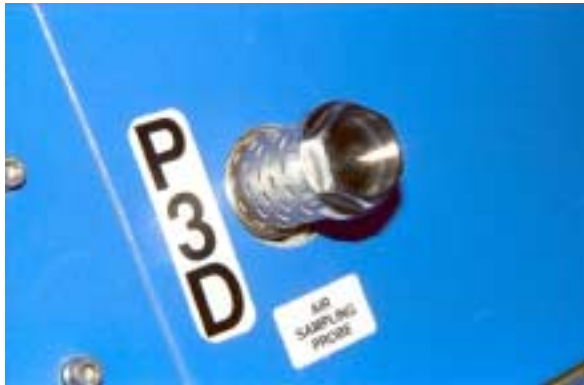
Node 1

- Observation:
Current Airlock sample port design could allow MCA to give erroneous partial pressure readings
- Discussion:
Airlock sample port is recessed into close-out
Current configuration of Airlock sample port could sample mostly behind the close-out
Sample port should be in the direct flow of the cabin, especially during depressurization to 10.2 psia and during 10.2 psia operations
 - Possibly cause the oxygen partial pressure to exceed 30% during Airlock 10.2 psia operations
- Risk assessment: Low
CSA-CP as redundant method to monitor oxygen partial pressure at any location desired
EVA dry run on flight day 6 will be used to determine actual offset compared with CSA-CP

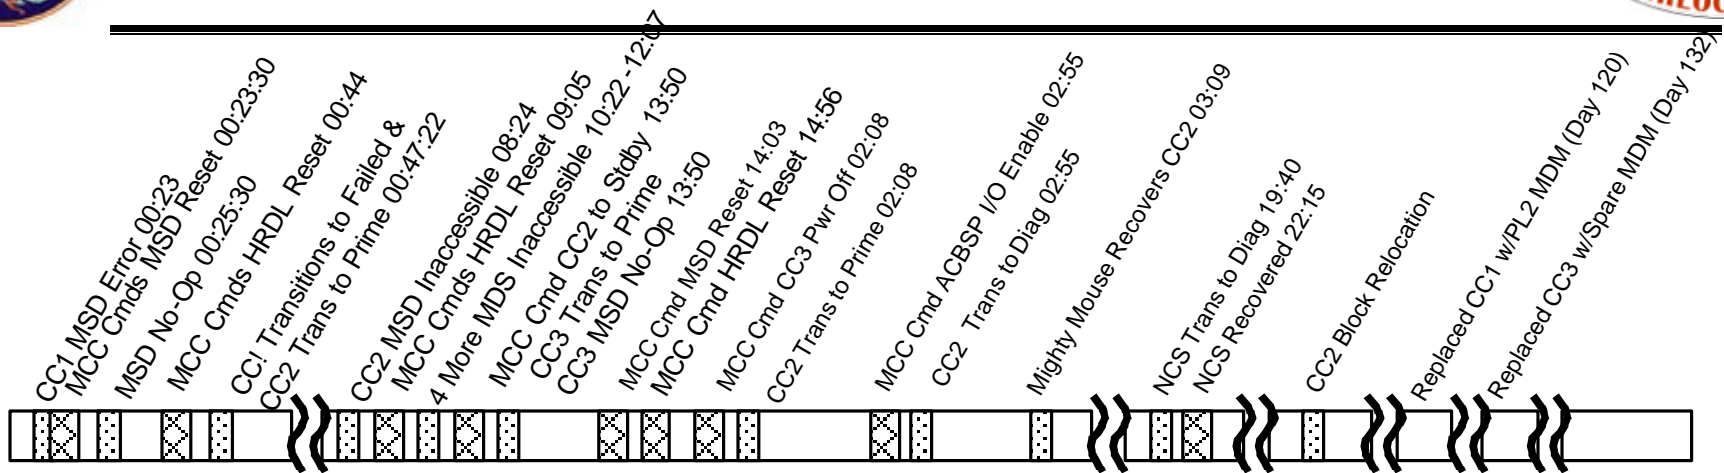
CC Failure Timeline

Prime	CC1	CC2	CC3	CC2		CC2	CC3
B/U	CC2	CC3				CC3	CC1
Stdbby	CC3		CC2				CC2
Other		CC1 - Failed	CC1 - Failed	CC1 - Failed CC3 - Off	CC1 - Failed CC2 - Diag CC3 - Off	CC1 - Failed
